Thermomechanical Testing Techniques for High-Temperature Composites: TMF Behavior of SiC(SCS-6)/Ti-15-3

Michael G. Castelli
Sverdrup Technology, Inc.
Lewis Research Center Group
Brook Park, Ohio

J. Rodney Ellis and Paul A. Bartolotta
National Aeronautics and Space Administration
Lewis Research Center
Cleveland, Ohio

Prepared for the
10th Symposium on Composite Materials: Testing and Design
sponsored by the American Society for Testing and Materials
San Francisco, California, April 24-25, 1990

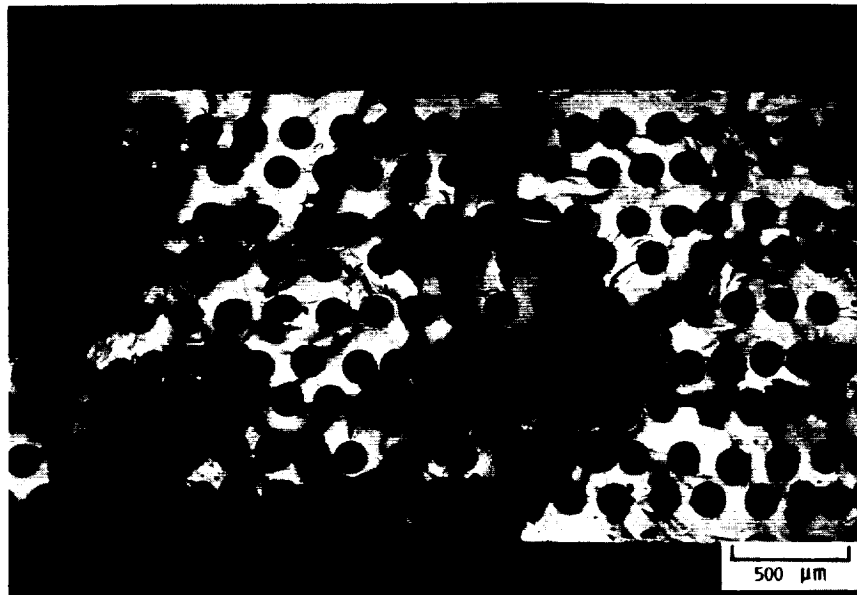
FIGURE 8. - TYPICAL SEM BACKSCATTER FRACTOGRAPHIS TAKEN FROM THE $\sigma_{MAX} = 896$ MPa ISO-THERMAL TEST PERFORMED AT 427 °C.

Typical Scanning Electron Microscope (SEM) fractographs taken from the $\sigma_{\max} = 896$ MPa isothermal specimen are shown in figure 8. In general, the fracture surfaces from all of the isothermal specimens were very similar, revealing flat regions of fatigue cracking accompanied by randomly distributed areas of fiber pull-out and ductile matrix failure. The higher stressed specimens displayed a slightly increased amount of fiber pull-out and ductile matrix failure. Oxidation patterns and SEM backscatter imagery strongly suggest that matrix cracking was initiated at both surface and internal fiber/matrix interface locations. Matrix "river" patterns suggest that there were numerous crack initiation points, and that the cracks have propagated only short distances (≈ 1 to 2 fiber rows) before coalescing. This relatively short crack growth may be a result of the fibers hindering fatigue crack growth.

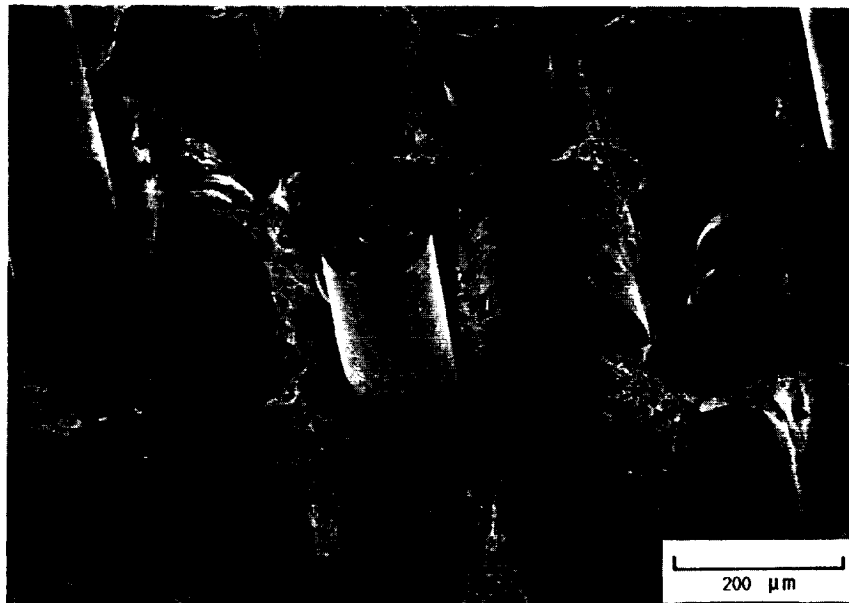
FIGURE 15. - TYPICAL SEM FRACTOGRAPHS TAKEN FROM A SPECIMEN SUBJECTED TO IN-PHASE LOADING
WITH $\sigma_{MAX} = 895 \text{ MPa}$.

In contrast, metallography from specimens subjected to in-phase TMF conditions exhibits trends which are quite different from those seen in isothermal and out-of-phase TMF specimens. Typical SEM fractographs taken from an in-phase specimen, $\sigma_{\max} = 896$ MPa, are shown in figure 15. This figure reveals extensive fiber pull-out and ductile matrix failure across the entire fracture surface. In fact, the features illustrated here (and from all other in-phase tests performed) most closely resemble those displayed by specimens subjected to tensile tests (ref. 12). This pattern of
